SUBMERGED:
Study of the Destruction of the Kakhovka Dam and Its Impacts on Ecosystems, Agrarians, Other Civilians, and International Justice

TRUTH HOUNDS

PROJECT EXPEDITE JUSTICE

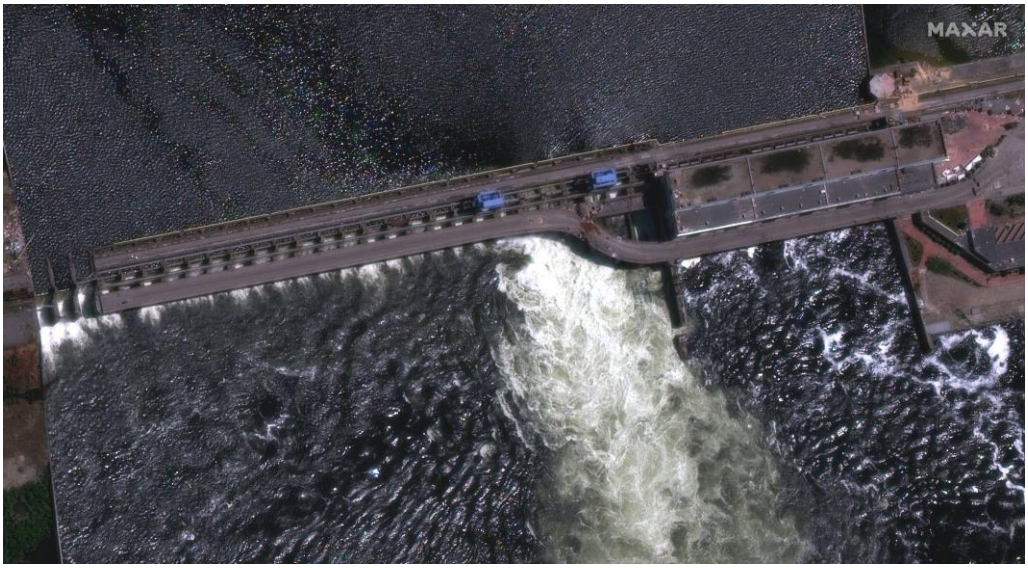
damaged or destroyed. At the time of the disaster, the water level in the Kakhovka Reservoir was at an exceptionally high level – 17.26 meters.[77] Satellite images show that water from the Reservoir overtops the sluices. These facts were used as evidence that the Dam could have gradually collapsed under the extreme water pressure.[78]

Kakhovka Dam on May 28, 2023. Source: @evanhill via X

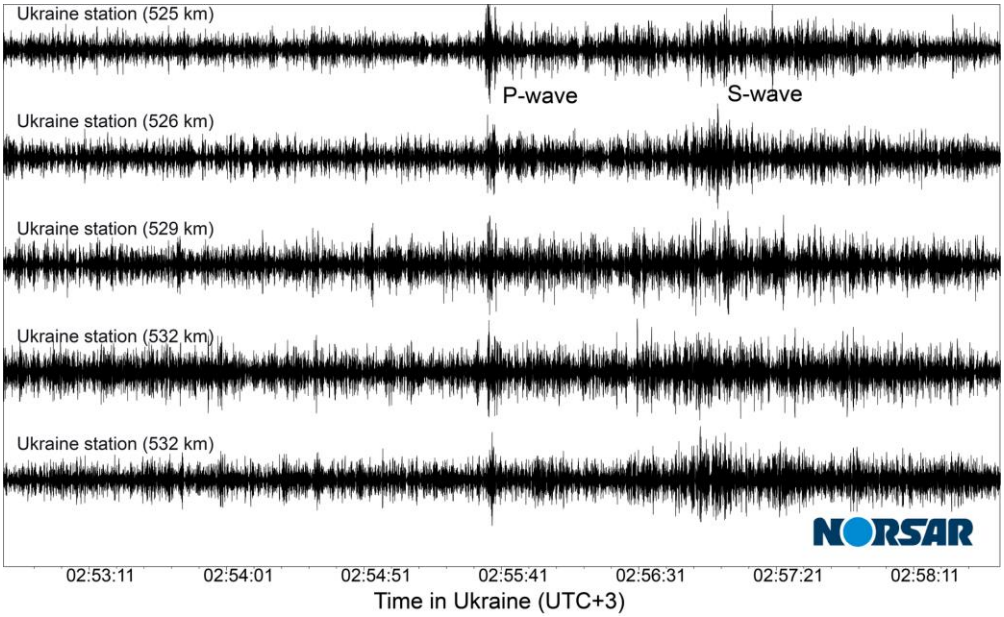
However, this theory overlooks several crucial facts. For instance, the NORSAR seismic stations in Ukraine and Romania recorded focused pulses of energy, which are typical of an explosion. The data reveals clear signals on June 6, 2023, at 2:35 AM and 2:54 AM.[79] Scientists report that the locations of both explosions were determined to be in the area of the Dam, albeit with an uncertainty of about 20-30 kilometers. This uncertainty arises from factors such as the distance from the Dam to the sensors (approximately 500-600 kilometers), the arrangement of sensors used for the location, measurement uncertainties, and unknowns related to the propagation of seismic waves in the Earth.

The magnitude estimated between 1 and 2 am on June 6. Source: Norsar

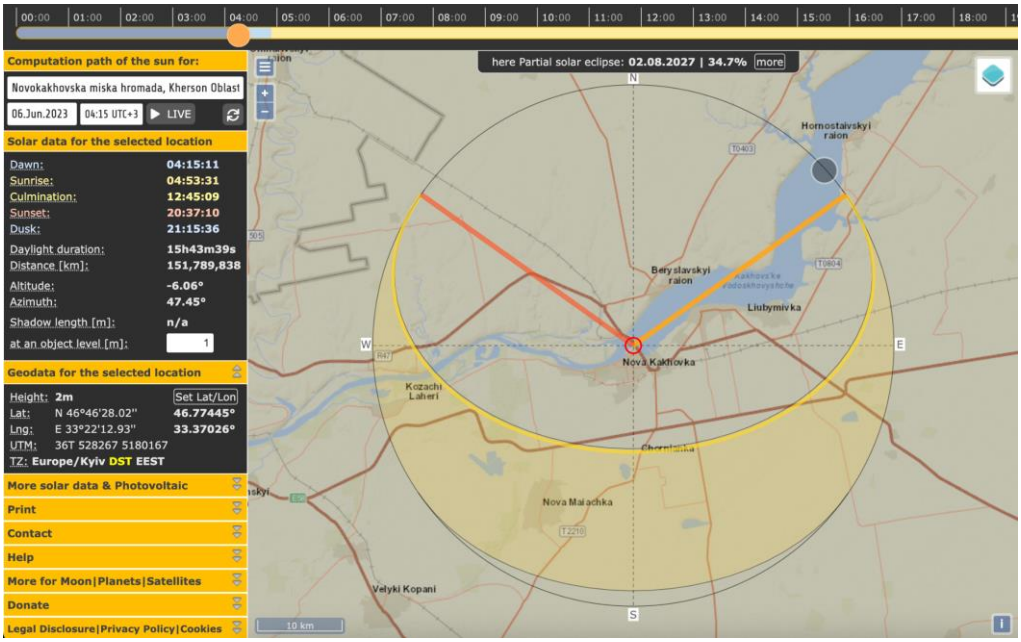
The exact recording time of this video is unknown but considering that the sun in the video is below the horizon, we can assume that it was recorded at dawn. According to the SunCalc service, the dawn of June 6, 2023, lasted from 4:15 to 4:53 AM.[88] This implies that this video was recorded 90-128 minutes after the one captured with a thermal imager. This timeframe does not appear sufficient for a water flow to have caused such damage to the power plant building. Moreover, if the building had collapsed due to water pressure, the collapse would have been initiated in the northern part of the building, near the site of the first breach, as that is where the water flow would have exerted the greatest pressure on the structure.

Sun position on June 6, 2023. Source: SunCalc

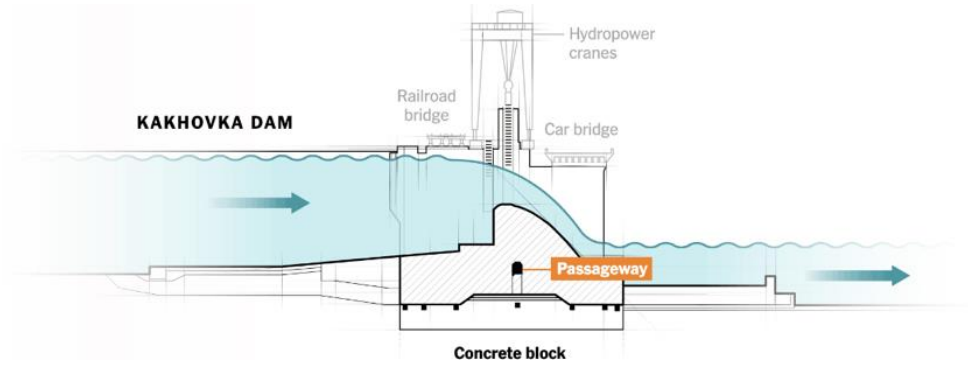
Ukrainian and foreign engineers note that a simple breach of the sluices or even the collapse of a few pillars under water pressure would not result in extensive destruction[90] and flooding.[91] They are convinced that such destruction most likely was caused by charges set deep in the Dam's structure. The most suitable location for the explosives is a technical passageway running along the concrete base of the Dam. The passageway is accessible only from the engine room, which was under Russian control.[92]

Scheme of the Kakhovka Dam and the location of the passageway. Source: New York Times

This version is further substantiated by the fact that one of the videos depicting the aftermath reveals the absence of the top of the concrete foundation at the location of the initial breach. Such large-scale destruction could likely have been caused only by an explosion deep within the Dam. If the Dam had simply been breached, only the sluices and pillars would have been affected, leaving the top of the concrete foundation intact.

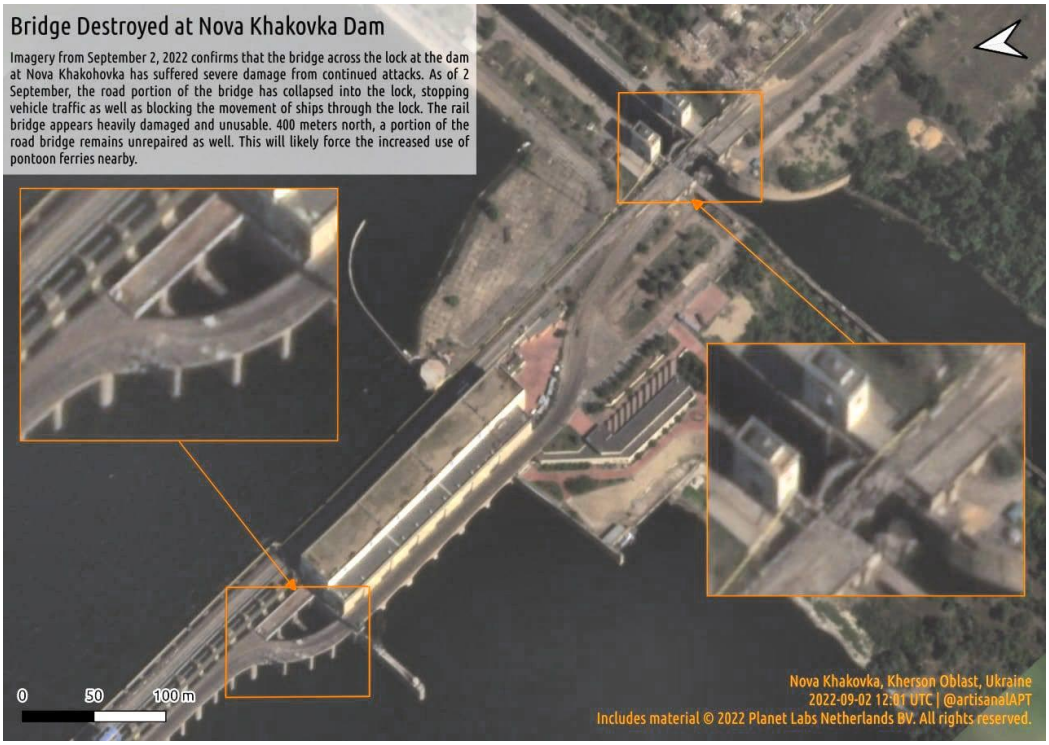
Bridge Destroyed at Nova Khakovka Dam
Imagery from September 2, 2022 confirms that the bridge across the lock at the dam at Nova Khakohovka has suffered severe damage from continued attacks. As of 2 September, the road portion of the bridge has collapsed into the lock, stopping vehicle traffic as well as blocking the movement of ships through the lock. The rail bridge appears heavily damaged and unusable. 400 meters north, a portion of the road bridge remains unrepaired as well. This will likely force the increased use of pontoon ferries nearby.
0
50
100 m
Nova Khakovka, Kherson Oblast, Ukraine
2022-09-02 12:01 UTC | @artisanalAPT
Includes material © 2022 Planet Labs Netherlands BV. All rights reserved.

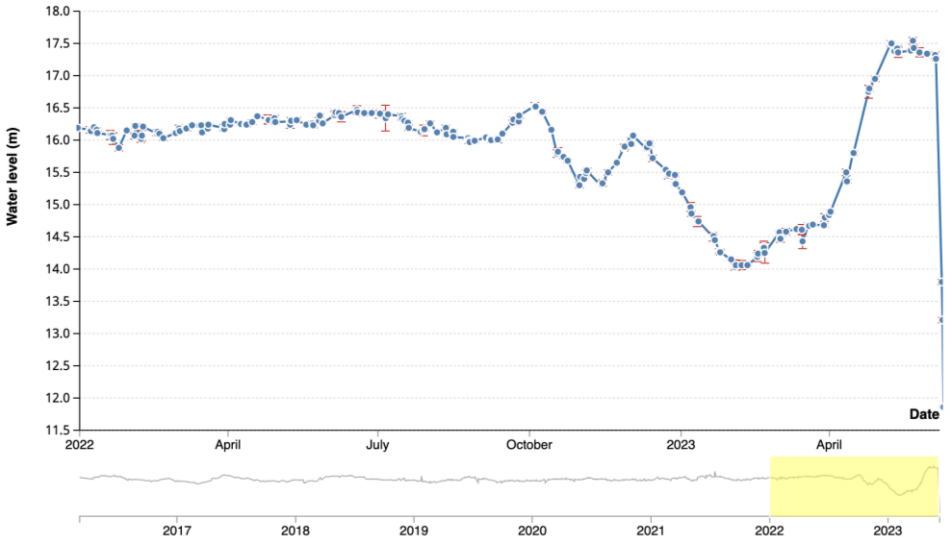
Water level dynamic from December 2022 to July 2023. Source: Hydroweb[138]

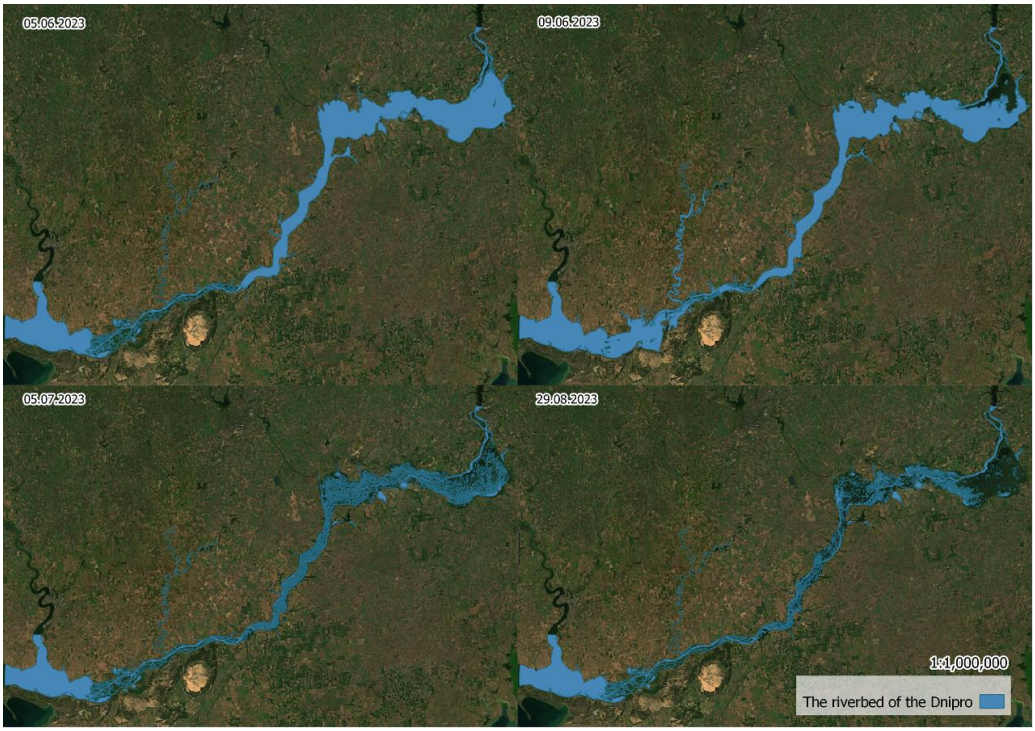
General plan of the entire area of interest with water masks for all available dates, showing water movement for the period from June 5, 2023, to August 29, 2023. The most severe flooding of the area below the Dam is observed in the image from June 9, 2024, then the water gradually recedes. At the same time, a gradual decrease in the water level in the Reservoir is observed.

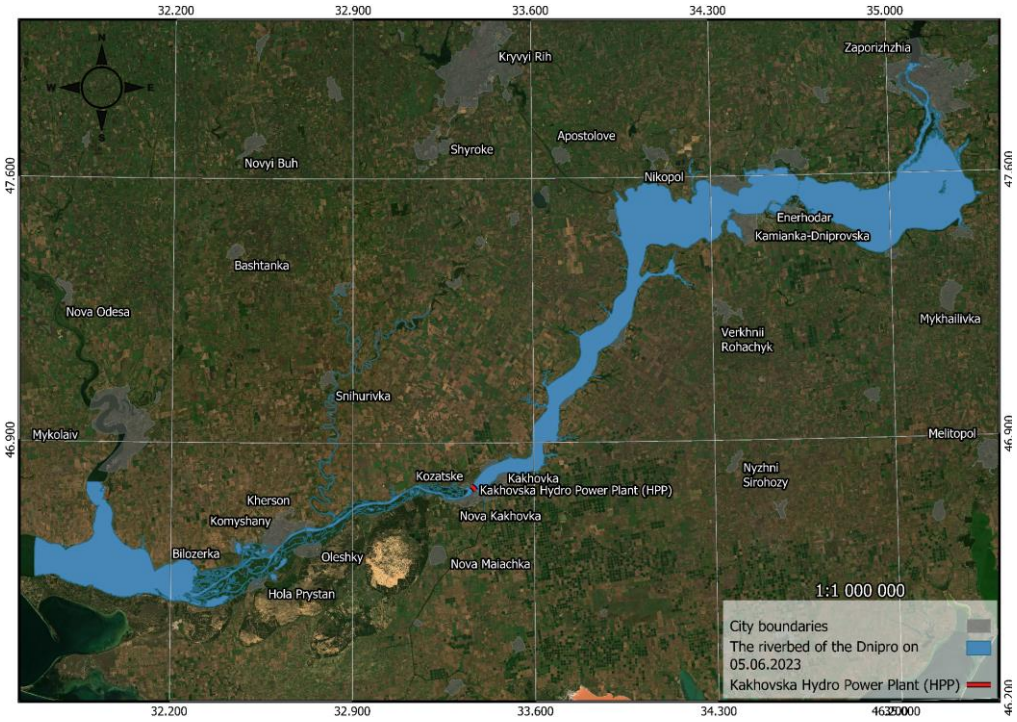
Water mask for the entire territory of interest (geographical scope of water movement analysis) based on the satellite image from June 5, 2023

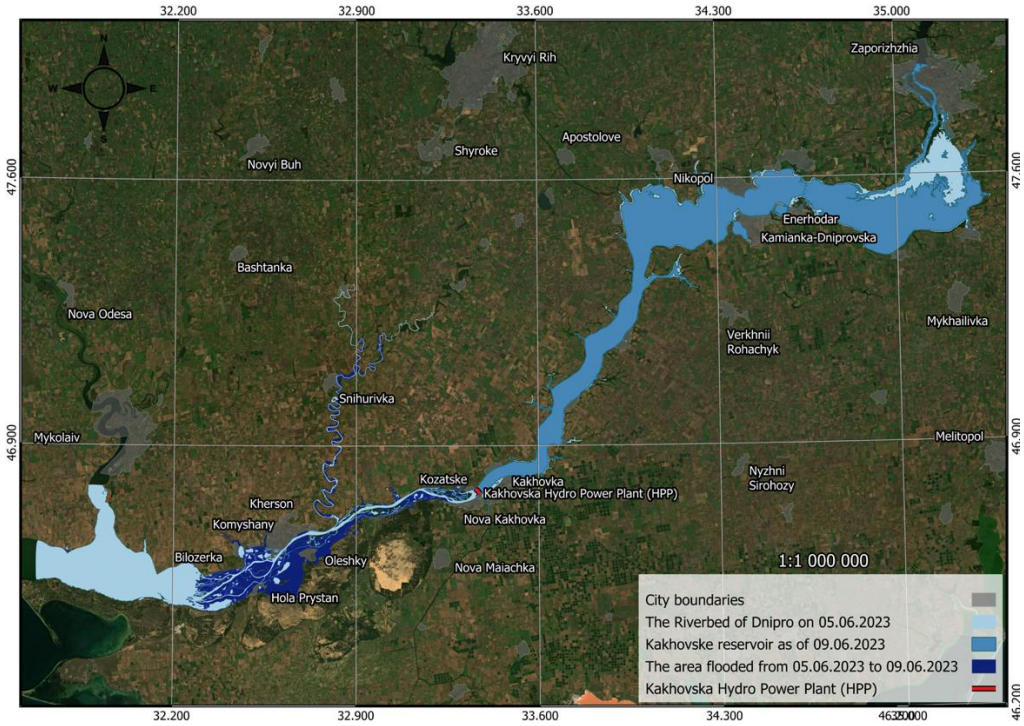
Difference in water mask for the entire territory of interest (geographical scope of water movement analysis) based on the satellite image from June 9, 2023, the third day after the explosion of the Dam

The difference in water mask[167] for the entire territory of interest above shows that the most significant flooding on both banks of the Dnipro River after the Kakhovka Dam breach took place on June 9, 2023. Notably, substantial flooding was observed in the buffer zone of the Inhulets River, the area downstream of the Dam, and in the area near Kherson and the Oleshky. Additionally, the mapping presented above clearly shows that the area upstream of the destroyed Dam, in Kakhovka Reservoir near Zaporizhzhia, was slowly being drained.

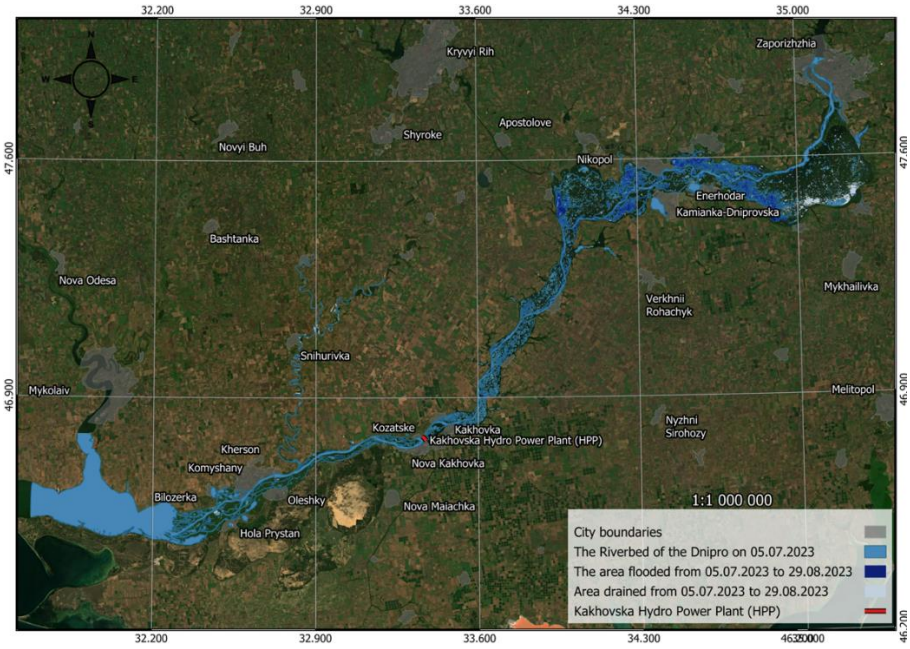
Difference in water mask for the entire territory of interest (geographical scope of water movement analysis) based on the image from August 29, 2023

The final water mask comparison for the entire area of interest, based on satellite image from August 29, 2023, almost 3 months after the disaster, shows a further decrease in water levels both downstream and upstream. However, over 17.8 km² of land remained submerged. Significant drainage is evident in the upstream zone, with the Kakhovka Reservoir and the Dnipro Riverbed notably drained, leaving much of the Reservoir empty.

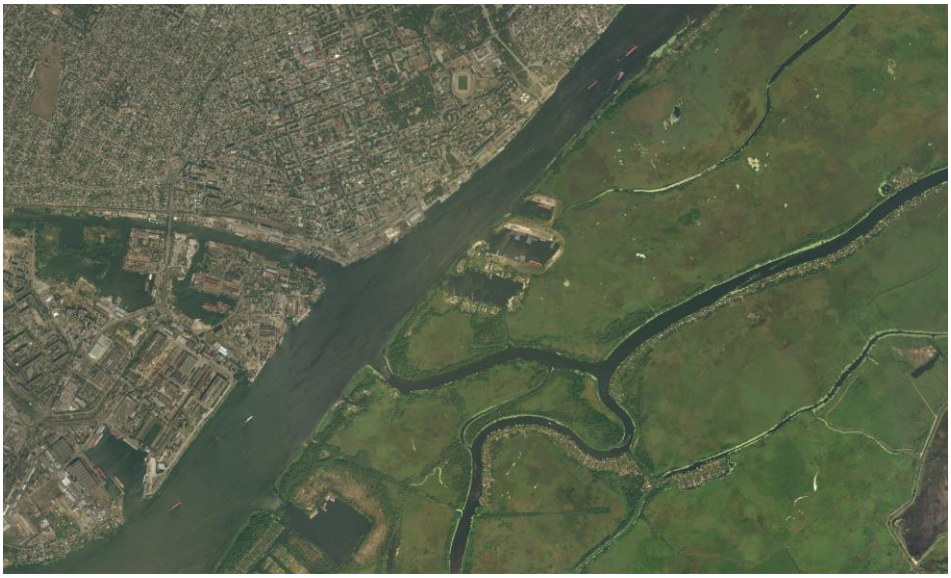
Flooding in Kherson Port area (location 2), Geosat image from June 7, 2023, resolution 0.75 m

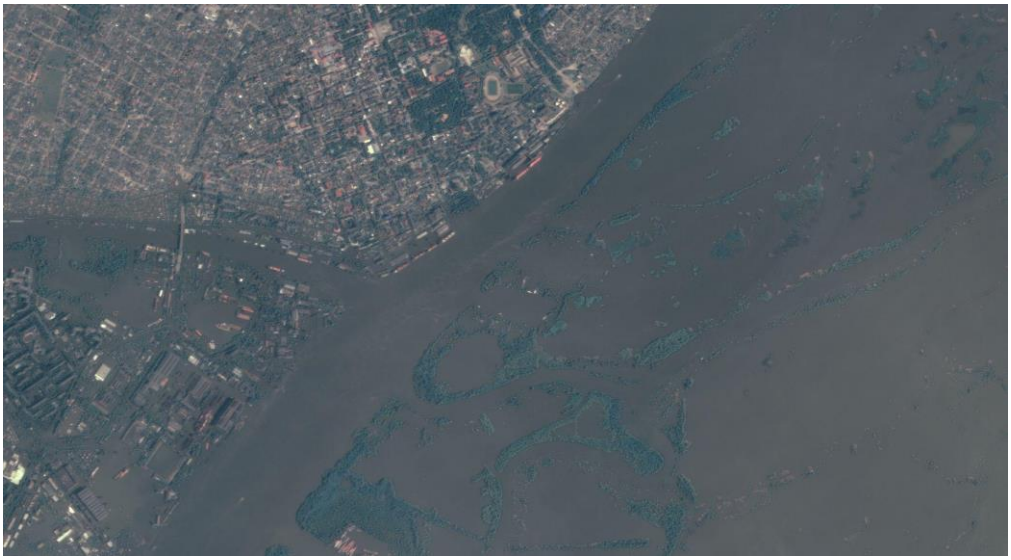
Flooding in Kherson Port area (location 3), Geosat image from June 7, 2023, resolution 0.75 m

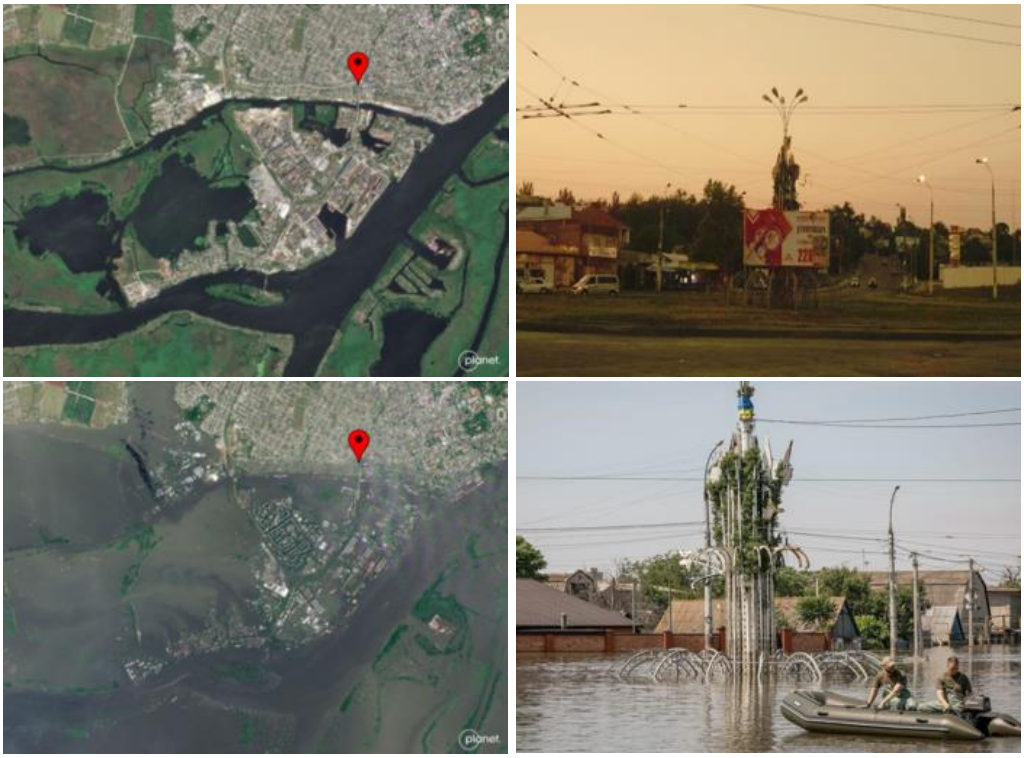
The satellite imagery of the Kherson Korabelna Square on May 15, 2023, and on June 7, 2023 (left). Photo of Kherson Korabelna Square before and after flooding on June 7, 2023 (right). Source: Planet Labs and REUTERS/Alina Smutko[180]

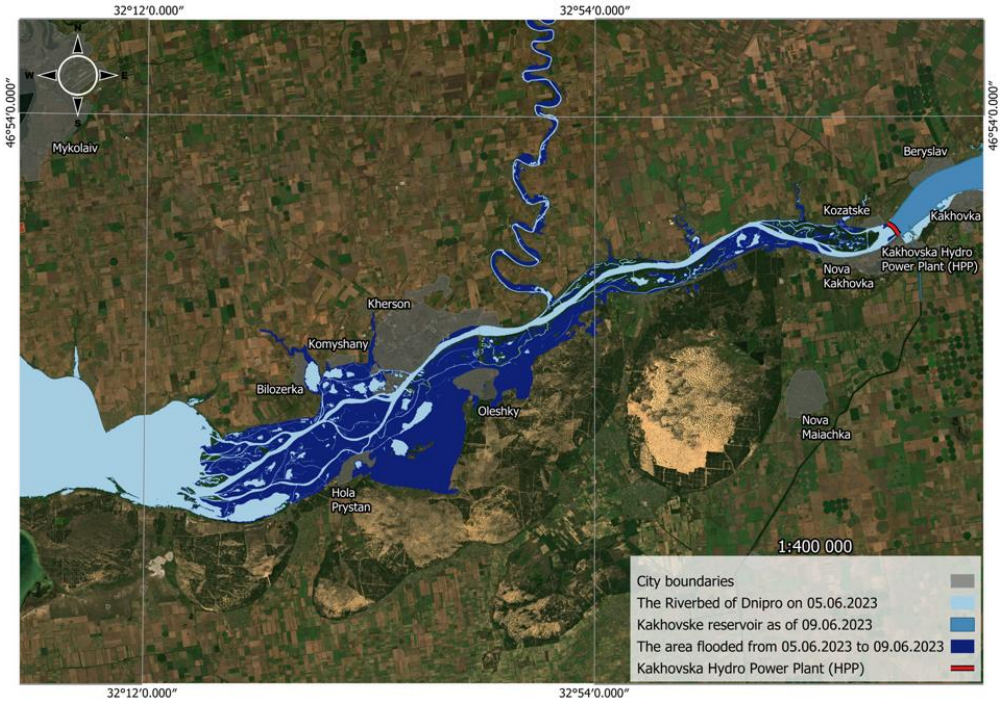
Difference in water mask for the downstream zone (geographical scope of water movement analysis) based on the satellite image from June 9, 2023

A water mask comparison for the downstream zone, based on satellite image from June 9, 2023, illustrates that 3 days after the Dam's collapse, the Dnipro River's water level had risen critically, causing severe flooding in several areas on both shores of the river. In particular, the comprehensive map demonstrates the complete inundation of the Kherson industrial zone and its vicinity, reaching the Biolzerka and Komyshany settlements. A significantly more severe flooding of the Russian-occupied left bank, especially in the towns of Oleshky and Hola Prystan, can also be observed.

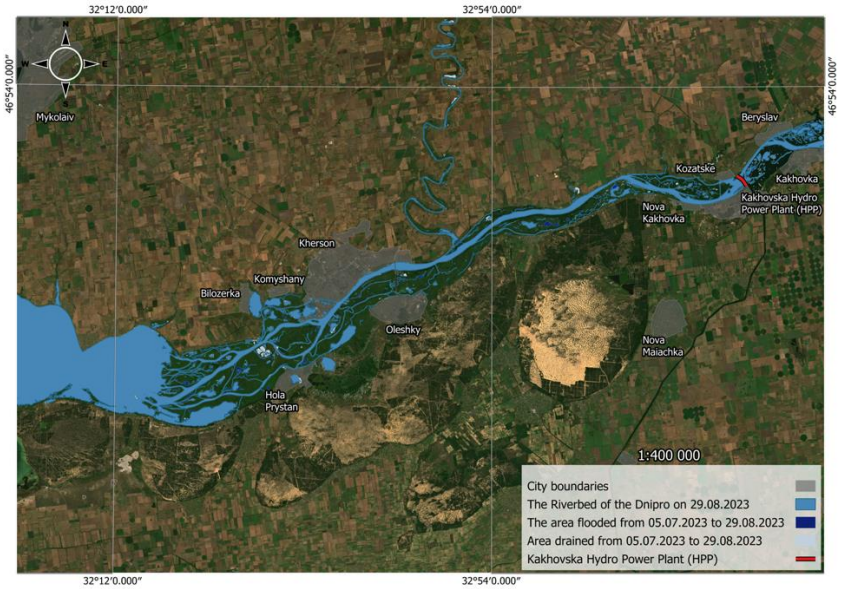
As previously noted, on August 29, 2023, nearly 3 months after the Dam's collapse, 17.8368 km² of land in Mykolaiv and Kherson Oblasts remained flooded. A closer examination of the water levels in the downstream and upstream zones through mask comparison shows a significant decrease in the Inhulets and Dnipro Rivers and Dnipro Riverbed. A large, drained area is visible within the Kakhovka Reservoir itself, which will be further detailed in subsection 3.2 below.

Difference in water mask for the downstream zone (geographical scope of water movement analysis) based on the satellite image from August 29, 2023

Difference in water mask for the upstream zone (geographical scope of water movement analysis) based on the satellite image from August 29, 2023

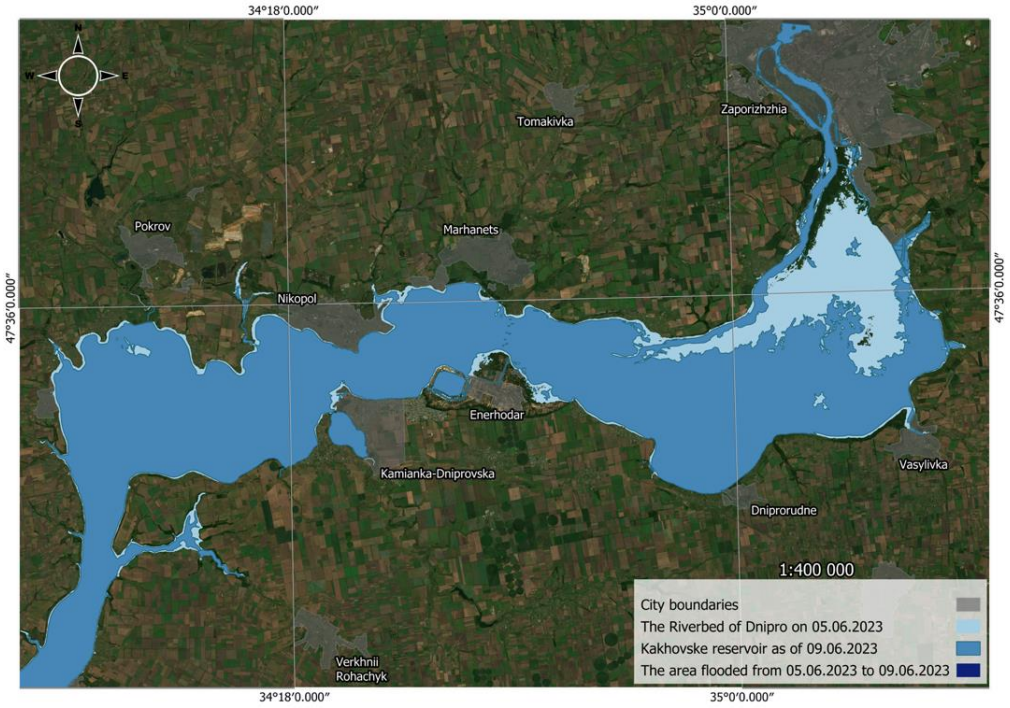
Difference in water mask for the Kakhovka Reservoir (geographical scope of water movement analysis) based on the satellite image from June 9, 2023.

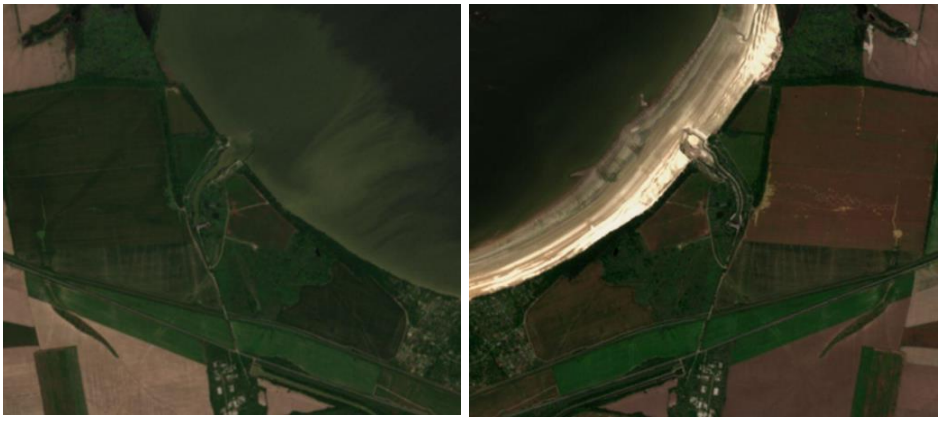
(ii) The satellite imagery of the inlet to the northernmost canal near Balky from the Kakhovka Reservoir on June 5, 2023 (left) and on June 20, 2023 (right). Source: Sentinel-2 L2A[220]

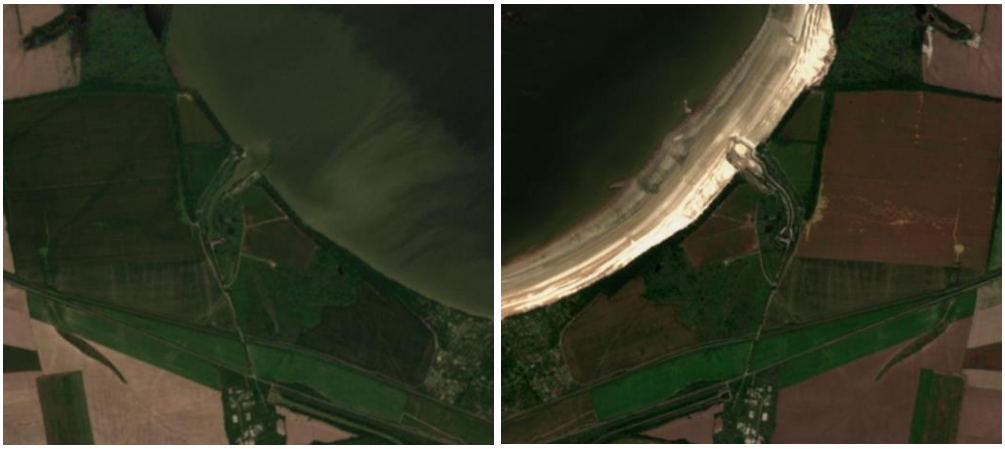
(iii) The satellite imagery of the inlet to the North Crimean Canal from the Kakhovka Reservoir on June 5, 2023 (left) and on June 18, 2023 (right). Source: Sentinel-2 L2A[221]

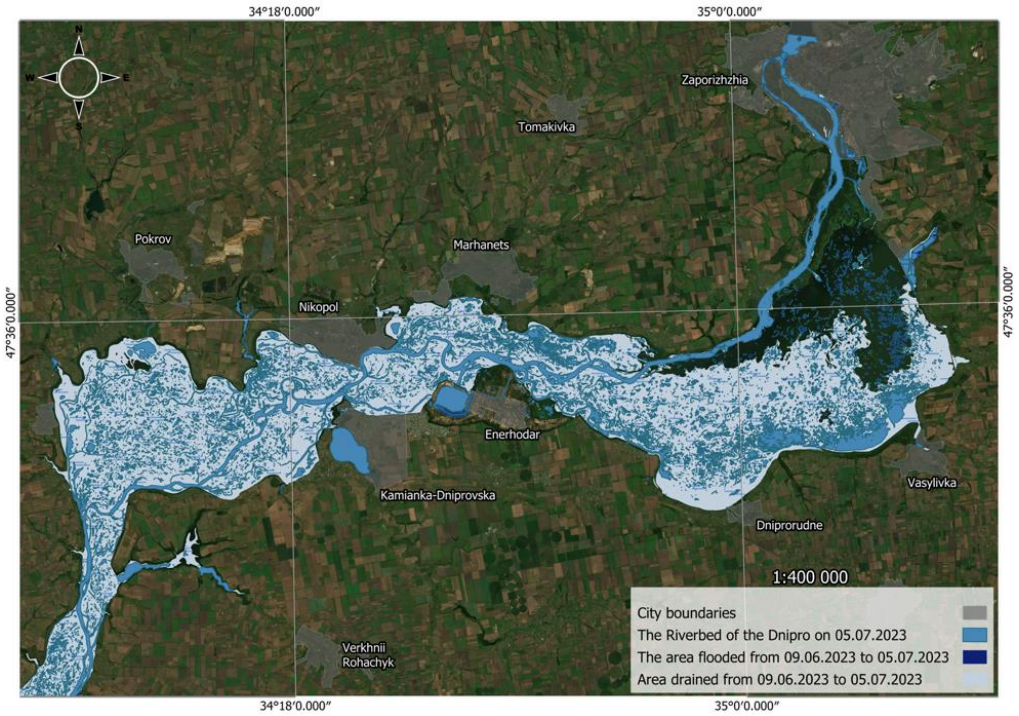
Difference in water mask for the Kakhovka Reservoir (geographical scope of water movement analysis) based on the satellite image from July 5, 2023

The additional satellite imagery of the Kakhovka Reservoir from July 5, 2023, processed by EOS through a difference in water mask, proves again that what once was a huge Reservoir has essentially become a large waterway composed of branches of the Dnipro River.

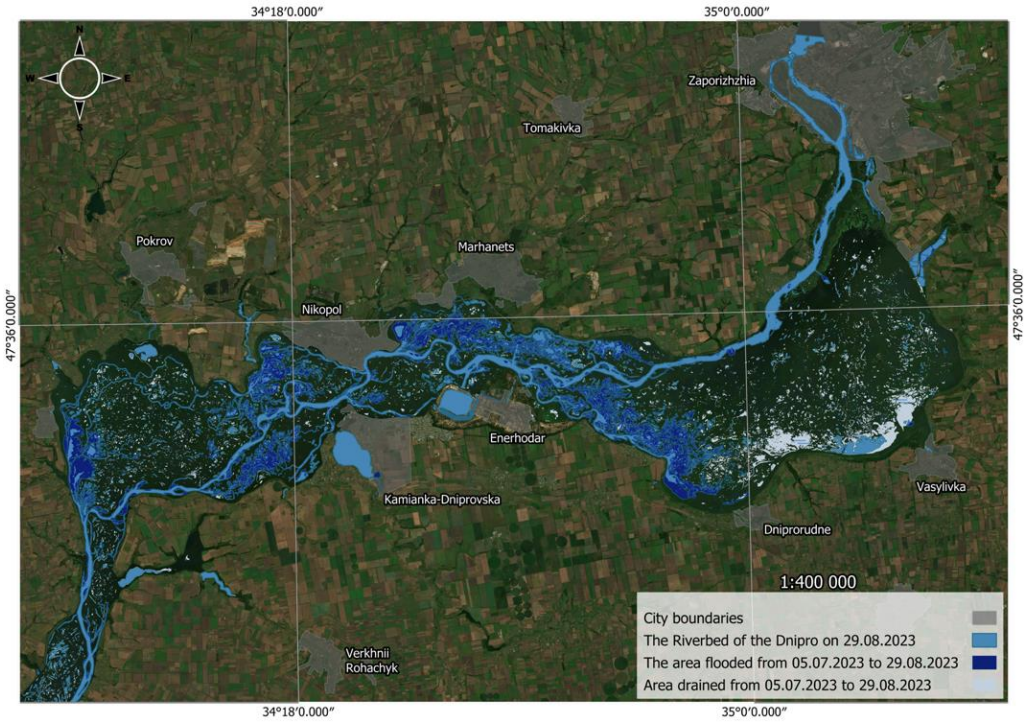
Difference in water mask for the Kakhovka Reservoir (geographical scope of water movement analysis) based on the satellite image from August 29, 2023

The comparison of the water mask based on satellite images from August 29, 2023, almost 3 months after the disaster, illustrates the fragmentation of the Kakhovka Reservoir into isolated bodies of water. While several larger water bodies remain connected to the Dnipro River channel, many medium and small water bodies have become isolated.[237]

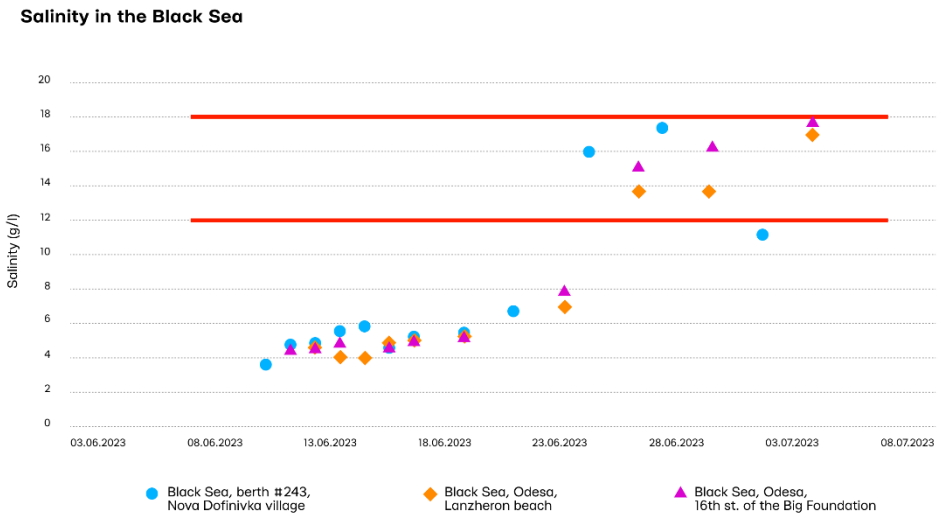
Salinity levels in the Black Sea from June 3, 2023, to July 8, 2023. Source: UNEP (2023) scale, created on the basis of State Agency of Water Resources data (2023)[335]

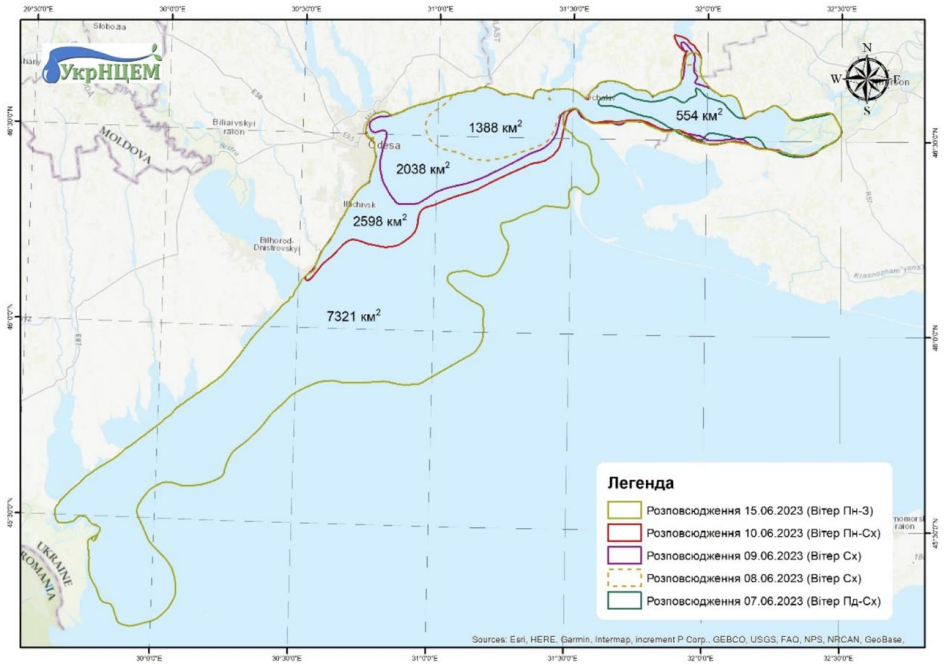
With the use of satellite imagery, the Ukrainian Scientific Center of Ecology of Sea ("UkrSCES") estimated that on June 15, 2023, within a week after the Dam's breach, the contaminated waters reached the Danube River, covering around 7,321 km^2 of the northwestern part of the Black Sea.[340]

A map based on satellite imagery showing the timeline of the spread of contaminated waters to the Dnipro-Buh Estuary and the northwestern part of the Black Sea. Source: UkrSCES[341]

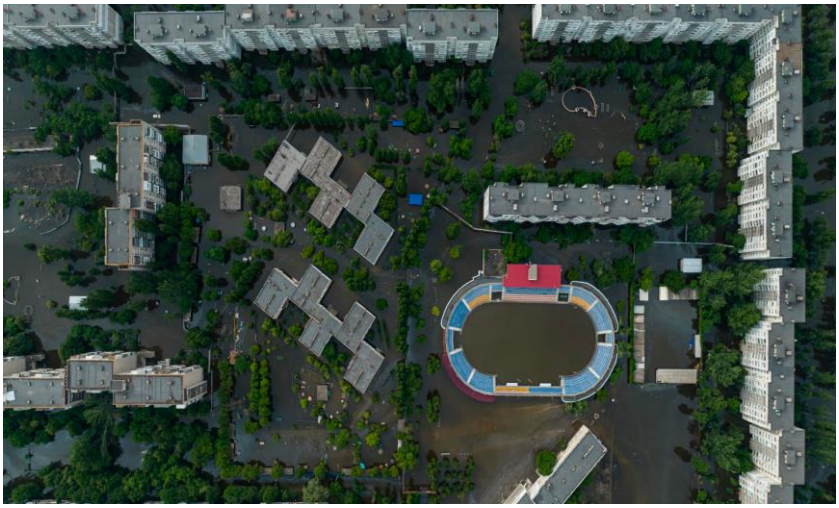
An aerial view of a flooded neighborhood in Nova Kakhovka showing polluted water. Source: AP NEWS/Keystone.[376]

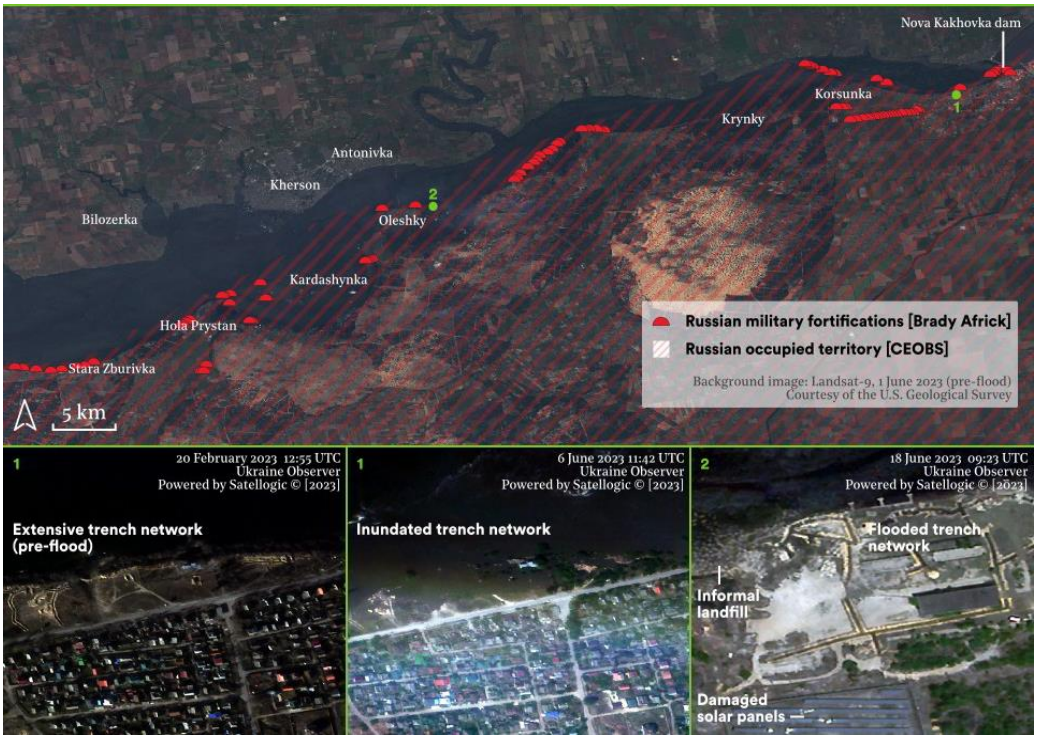
Satellite Imagery of flooded Russian trench work on the left bank of Dnipro.
Source: CEOBS, July 2023[453]
